REVIEW OF THE PRESENT CONDITION OF THE LUCINDA BULK SUGAR TERMINAL AT LUCINDA IN NORTH QUEENSLAND AUSTRALIA

Alan Carse
(Queensland Department of Main Roads
Structures Division
GPO Box 1412
Brisbane, Australia. 4001)

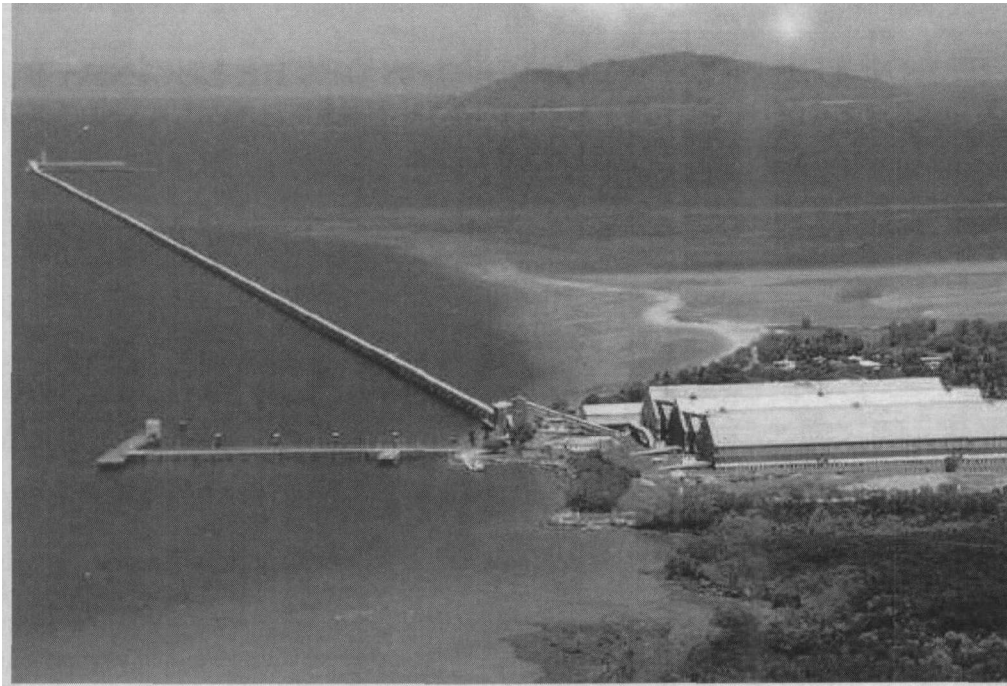
Fig. 1: General view of Lucinda Jetty structure

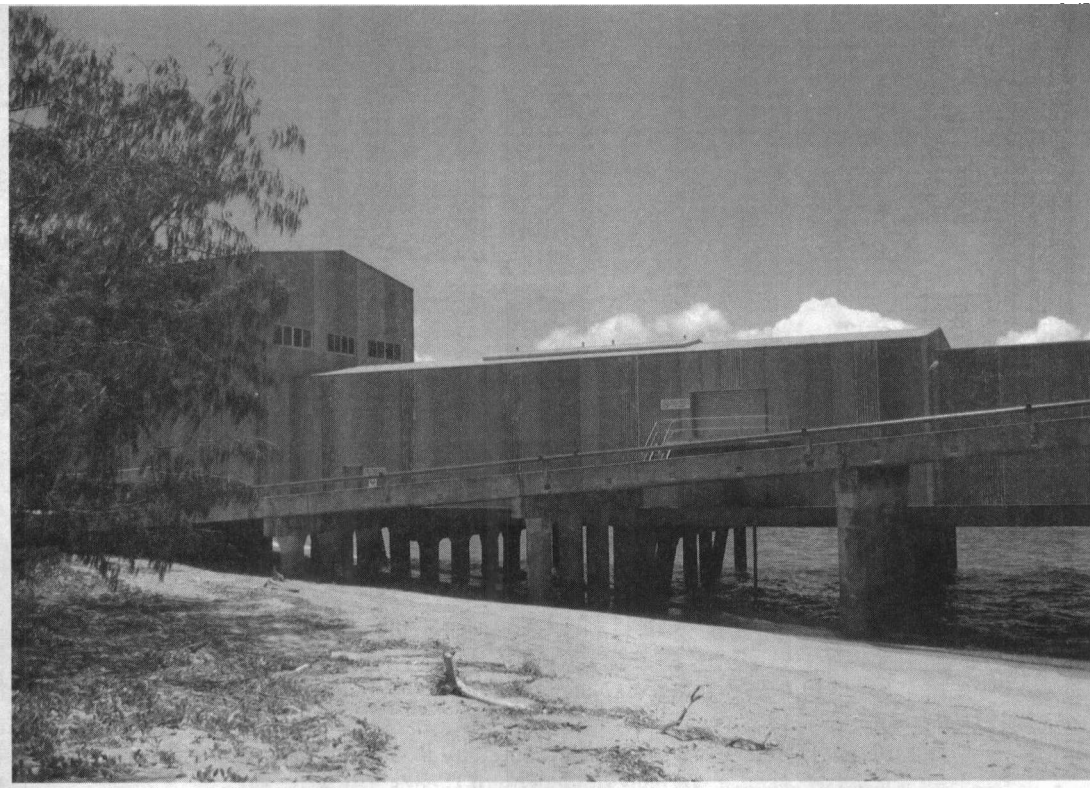
Since 1987, this structure has been monitored to plot its rate of deterioration due to ASR and ensure it remains in a safe condition to carry out normal operations. The information collected has also been used to optimise the ongoing maintenance strategies. Fig. 2 shows a general view of the Tail End Structure which accepts the sugar from the 3 sheds for transport along the conveyor. This part of the structure has the lowest clearance above the high water mark and hence is the location where significant corrosion has occurred due to the ASR cracking in the jetty beams. It is fortunate that the Tail End Structure is only 60 metres in length which

represents 1% of the Jetty length. Hence, 99% of the Jetty is well above the high water mark, which significantly reduces the risk of chloride ion penetration into the soffits of the beams.

Fig. 2 View of Tail End Structure showing proximity to high water mark

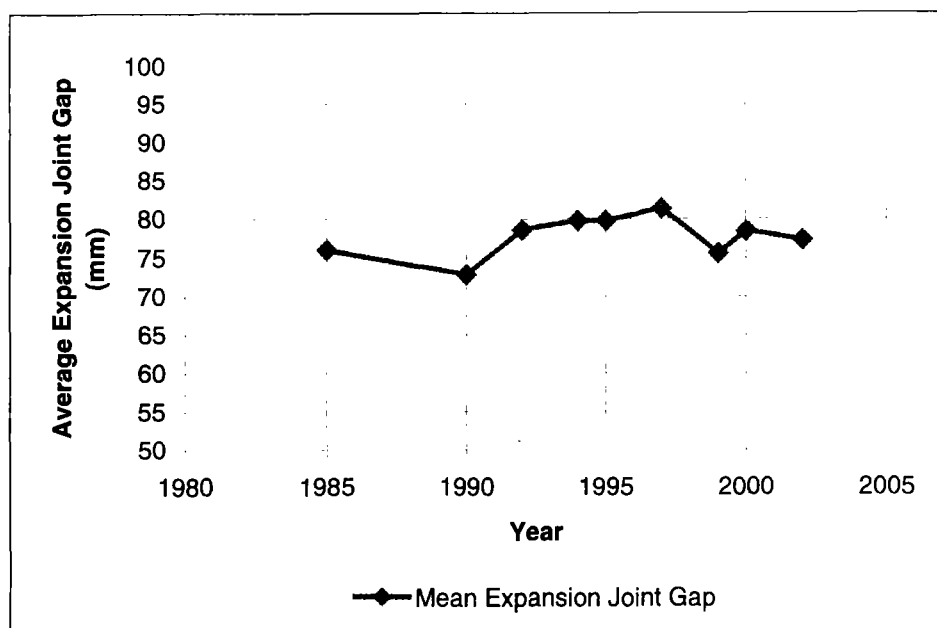
Table 1 and Fig. 3 detail the longitudinal measurements taken by the author over a representative sample of expansion joint gaps. It can be seen that the mean expansion joint gap of 77 mm varies by -4 and +3 mm over the 15 year

measuring period. If alkali-silica reaction (ASR) was causing any significant longitudinal expansion of the prestressed beams then the expansion joints should be reducing in width. The data in Table 2 shows this is not the case and hence it can be concluded that ASR is not causing any significant longitudinal expansion of the beams.

Fig. 3 Average expansion joint gaps from Table 1

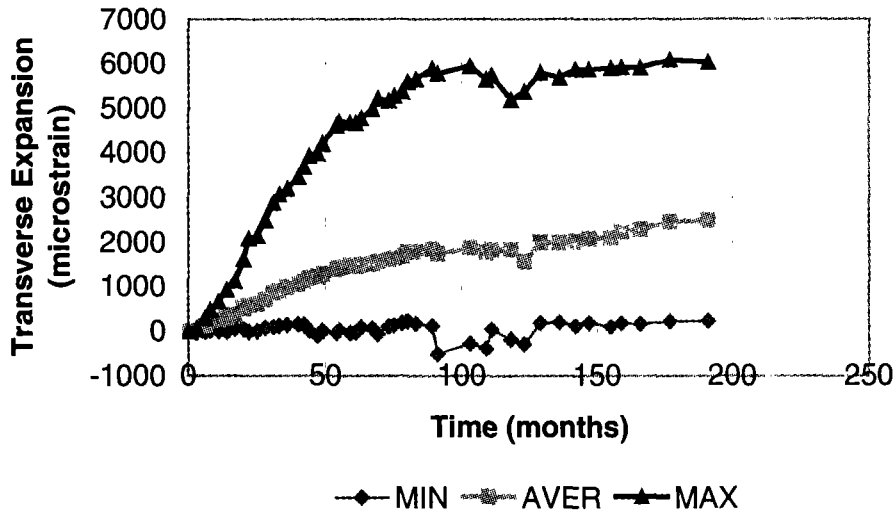
Fig. 4 graphically shows the minimum, average and maximum expansion that has occurred in Span 78. The maximum expansion of 6742 microstrain occurred at a duration of 191 months since the installation of the measuring system in December 1986. Since September 1999 this maximum expansion has remained static indicating the overall potential of the concrete to expand due to ASR has probably been reached. This level of expansion is consistent with that measured on equivalent Main Roads structures over estuarine creeks.

Fig. 4 Span 78 (no bitumen, no sealer) December 86 to September 2002
Maximum transverse expansion location

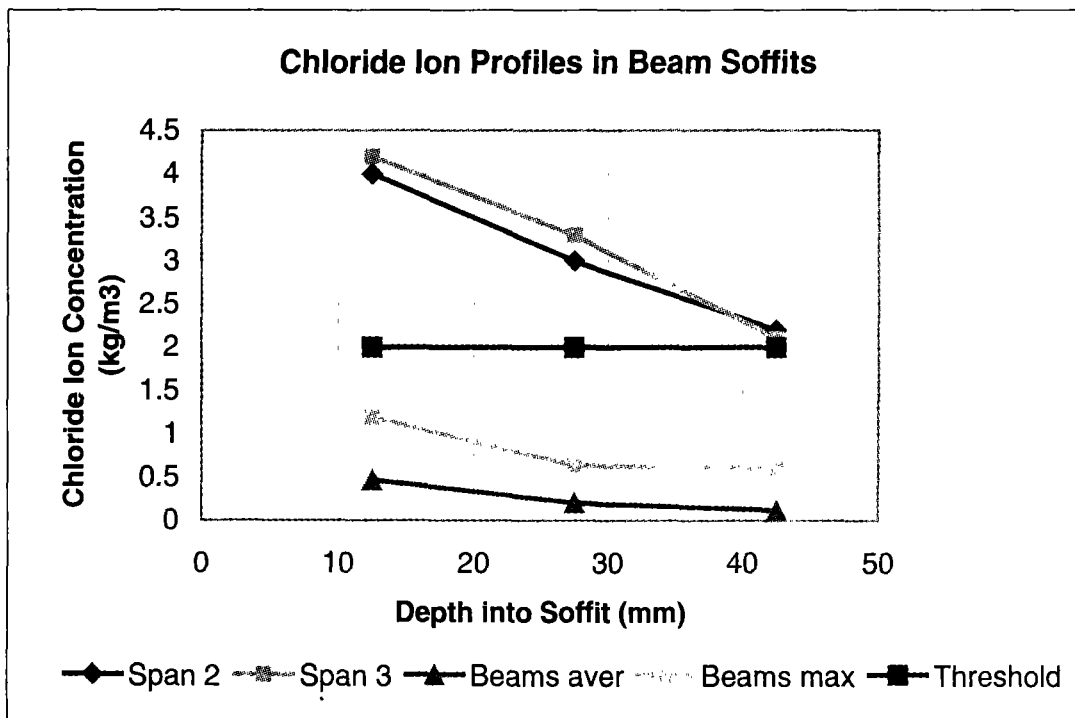
The chloride ion contents continue to provide critical information concerning the change in condition of this structure. Previous reports have shown the chloride ion levels to be ten times higher in the tail end structure beams compared with the roadway beam soffits. Fig. 5 shows a summary of the average chloride ion contents in spans 2 and 3 of the tail end structure and the roadway beams in 2002. The maximum chloride ion contents in the roadway beam soffits has also been included for comparison. The chloride ion threshold concentration for corrosion would be approximately 2 kg/m^3 for the beam concrete. Hence, Fig. 5 predicts corrosion is probably active in the tail end beams (which has been proven by physical inspection and repair) and not yet started in the roadway beams (also proven by physical inspection).

Examination of the chloride ion profiles in the soffits of the tail end beams shows they are increasing with time due to the level of ASR cracking. This is supported by the level of repair activity in this area. Since most of the structure is represented by the roadway beams the rate of increase of chloride ions in this zone is critical to the life cycle performance of the structure.

Fig. 5 Summary of the Chloride Ion Profiles in the Beam Soffits in 2002

The chloride ion content of the beam soffits in the Tail End Structure is increasing with time due to the level of ASR cracking (see Fig. 5). This result is supported by the level of repair activity required in this area. The chloride ion content of the roadway beam soffits in 2002 has reduced in relation to the 2000 values. Since most of the length of this structure is represented by the roadway beams the rate of increase of chloride ions in the beam soffits is critical to the life cycle performance of this structure. The chloride ion measurements taken in

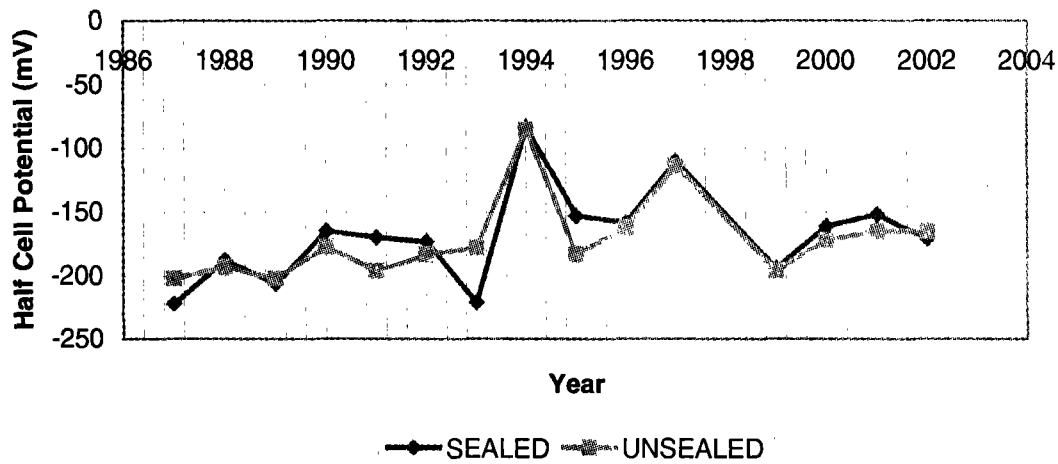
A comparison of results in 1987 when the sealers were applied and the September 2002 results is recorded in Table 5 (measurement period 15 years). Examination of Fig. 6 which shows a plot of the half cell potentials from a typical beam indicates that the sealed and unsealed sections are performing in a similar manner. Since the last report in 2000 the results have remained static. The current potential readings are similar to the initial values in 1987.

Fig. 6 Half Cell Potentials at a typical location in Span 78 Beam 4

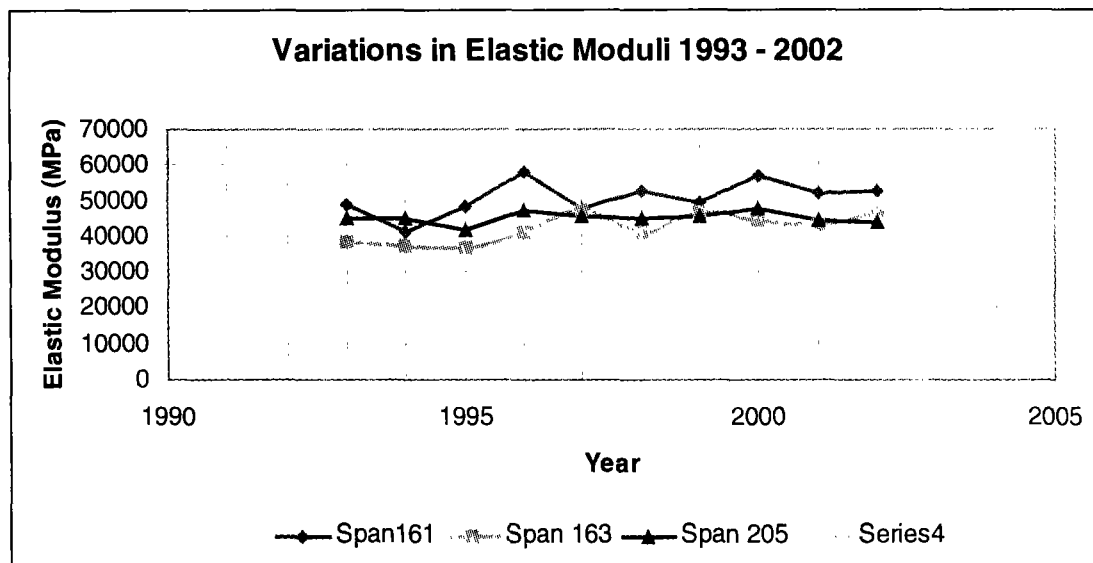
Spans 161, 163 and 205 are all showing a relatively constant stiffness, for measurements taken between 1993 and 2002 as recorded in Fig. 7.

Fig. 7 Variation in Elastic Moduli

All tested spans indicate a normal response was obtained with no significant change in long term stiffness.
