## TRAIÇÃO DAM - THE EVOLUTION OF THE ALKALI AGGREGATE REACTION (AAR) IN THE LAST 20 YEARS

Corrado Piasentin<sup>\*a</sup>, Marco Juliani<sup>\*b</sup>, Liana Becocci<sup>\*c</sup>, Carlos René Nunes Galvão Barreto<sup>\*d</sup>  
(<sup>\*a</sup> Consultant, Av. Rainha Elizabeth, 371, Apto 806, CEP 22081-030, Rio de Janeiro, Brazil)  
(<sup>\*b</sup>, <sup>\*c</sup> IEME BRASIL Ltda., Rua Miragaia, 209, CEP 05511-020, São Paulo, Brazil)  
(<sup>\*d</sup> EMAE, Av. Nossa Senhora do Sabará, 5312, Escritório 35, CEP 04447-900, São Paulo, Brazil)

The Traição Dam, situated on the Pinheiros river in the city of São Paulo, was built in the period of 1938–1940. After a few years of operation, fissures, leakage and deformations occurred in the concrete causing problems with the operation of the machines. In 1995, the presence of alkali-aggregate reaction (AAR) was diagnosed as a cause of the concrete expansion. The analysis of the readings from the instrumentation installed in the last 20 years and the studies carried out recently indicate that the AAR phenomenon has already passed its peak and is in the course of declining. A program of monitoring is being implemented to follow up the ph

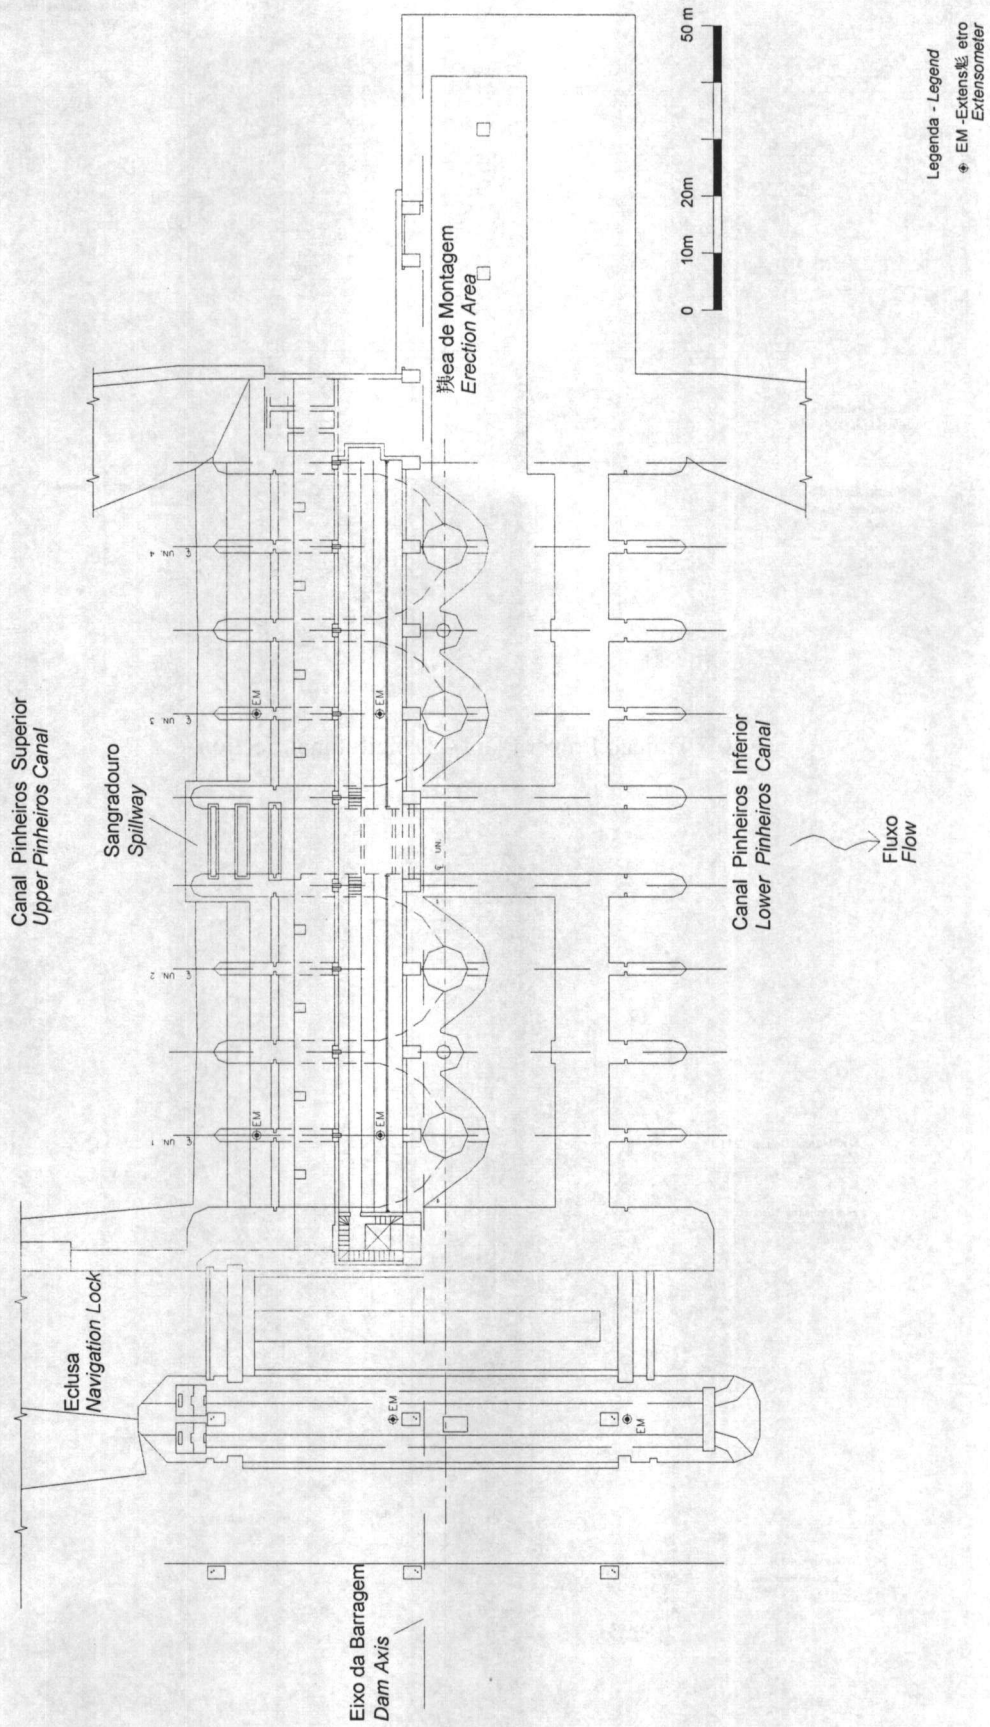
Fig. 4 Traição Power Plant – Plan View

Figs. 4, 5 and 6 show the simple and multiple vertical extensometers installed in the structures, that allow measuring the expansion of the concrete and the settlement the foundations.

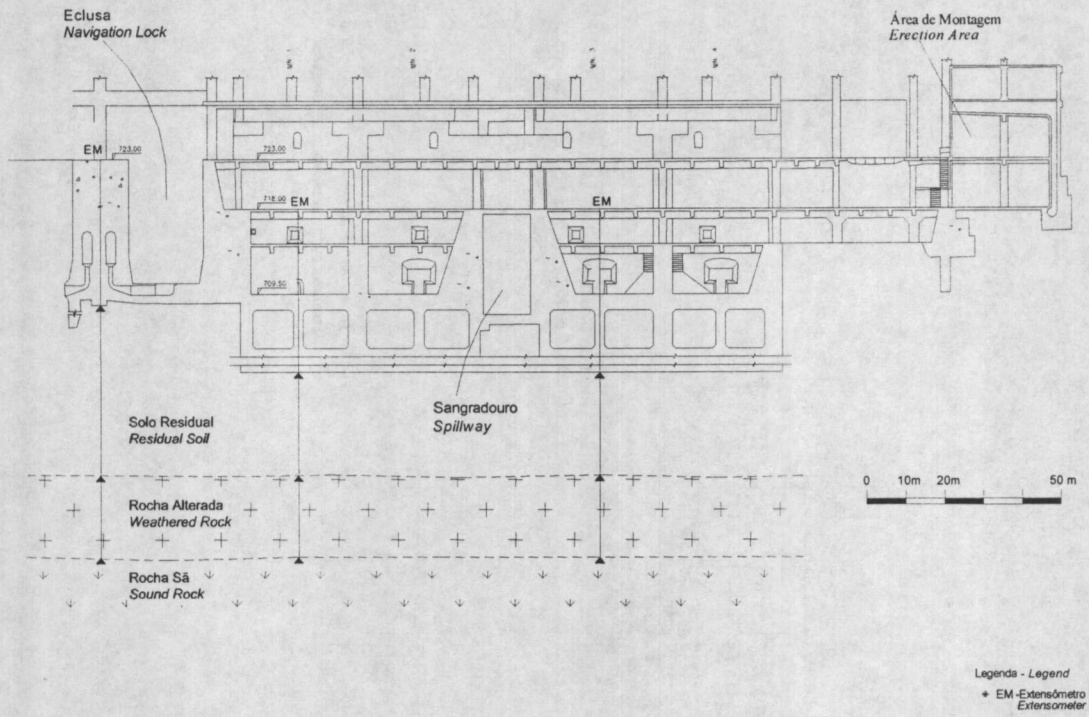
Fig. 5 Traição Power Plant – Longitudinal Section

The foundations (Fig. 5 and Fig. 6) are composed of sandy silt to stiff clay, residual soils produced by the weathering of the magmatic rock. The sound rock dives in the direction of the eastern (right) abutment, being found at a depth of 4 m in

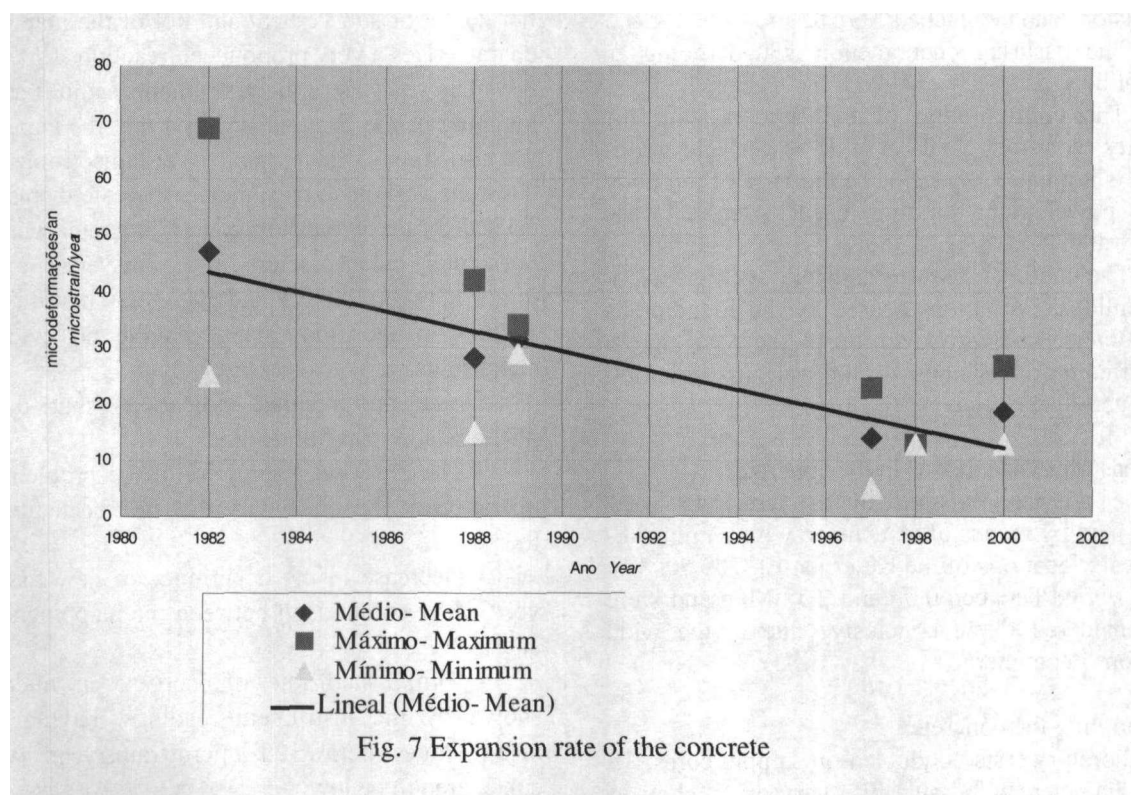
The values of this table are shown in the graph of Fig. 7, where the straight line of the mean values trend clearly indicates the decrease in the expansion rate of the concrete with present values below 20 microstrain/year.
