ALKALI REACTIVITY OF AGGREGATES AND AAR-AFFECTED CONCRETE STRUCTURES IN BEIJING

ABSTRACT

3 SURVEY AND ANALYSIS OF DETERIORATED STRUCTURES

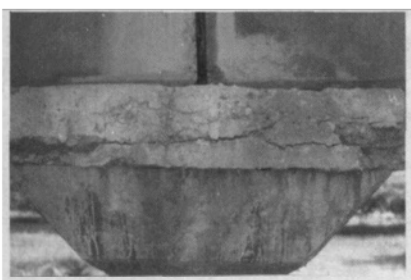
Fig. 2 Sanyuan cloverleaf junction

Sanyuan cloverleaf junction is a large-scale junction built in the middle of 1980's. According to the report, since concreting of the secondary beams was carried out in the last ten days of March, when the outdoor temperature was low, 5% (by weight of cement content) of NaNO_2 was added in the mixing. Yongding River aggregate was used as coarse aggregate of the concrete. Serious cracks occurred on part of the secondary beams and main beams and part of the concrete are loosened. Dotted rusts of reinforcement are found in the cracks (figure 2).

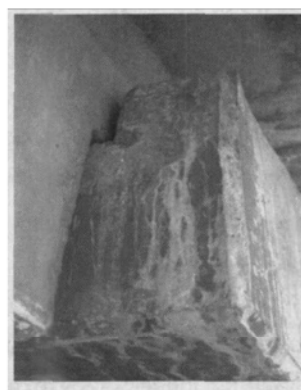
Fig. 3 Secondary beams of Beiyao cloverleaf junction

Beiyao cloverleaf junction initially built in June 1986 and completed in November of the same year. The bridge is supported by precast R.C. T-beams with a wide web, under the T-beam are the secondary beams. To date, network-shaped cracks have developed on part of secondary beams (Figure 3). Longitudinal cracks are also observed on individual T-beams and dotted rusts of reinforcement can be seen in cracks.
